# Khoo Inspection Services

## Property Inspection Report

**Client(s):**  
**Property address:**  
**Inspection date:** Tuesday, October 25, 2016

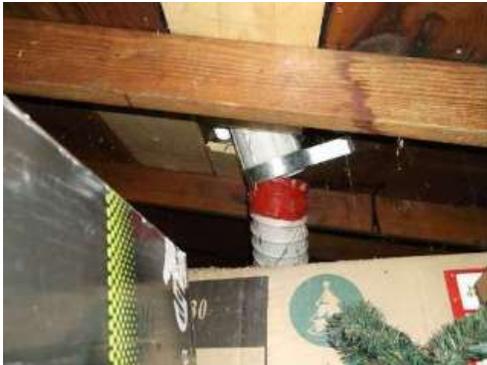
**Photo 3-1**

The clothes dryer flexible ventilation duct is partially detached from the roof vent. This will allow excessive moisture to buildup in the attic. Recommend the duct is reattached to the vent.

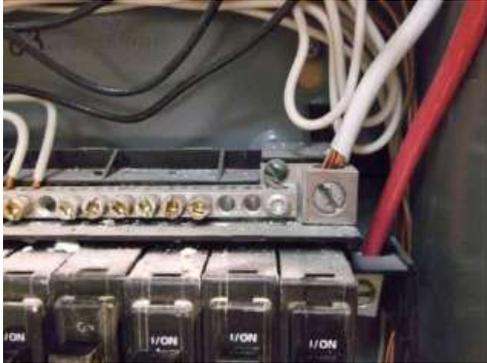
**Photo 5-1**

It appears that the sub-panel located in the laundry area has its neutral bar grounded (see attached photo). If this is the case, then a potential hazard for electric shock exists. Grounding should only exist in the main service panel. The National Electrical Code (NEC) has prohibited re-grounding the neutral after the service since the 1923 edition. Exceptions have been made for dryers and ranges that use the neutral as a grounding means, and for separate buildings. However, those loopholes have been effectively closed in the 1996 and 1999 editions of the NEC. Recommend that a qualified electrician evaluate the bonding and remove the screw is necessary.

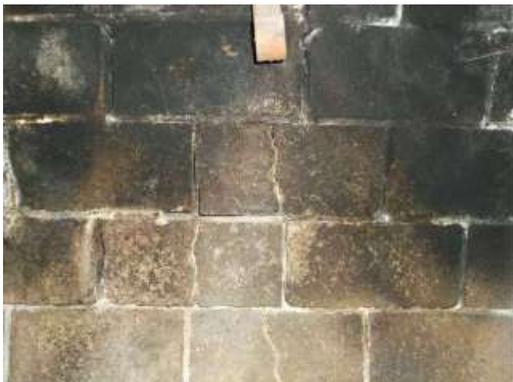
## Photo 10-1

Many of the fireplace bricks are broken and/or the joint mortar is deteriorated. Approximately six bricks appear to be in need of repair or replacement. A qualified contractor should evaluate and make repairs as necessary.

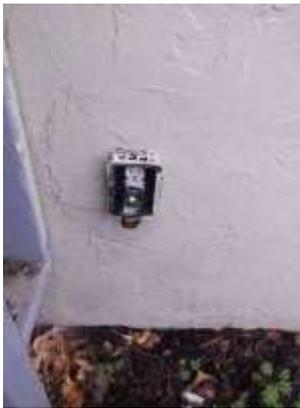
Photo 11-1

Two exterior electrical receptacles, one on the west side and one on the south (rear) of the structure are not grounded and appear to have no GFCI protection. Additionally, the weather-proof cover for the receptacle on the west side of the structure is missing. These are all safety issues and recommend they are evaluated and repaired by a qualified electrical contractor.

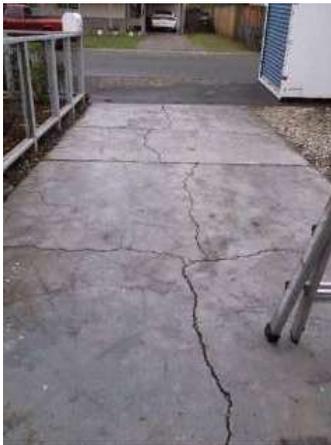
Photo 12-1

The driveway has moderate cracks and/or deterioration in one or more areas. A qualified contractor should evaluate and repair or replace driveway sections as necessary.

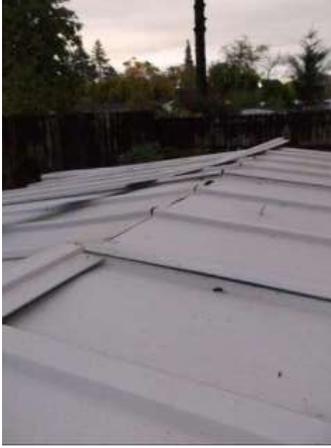
**Photo 13-1**

The metal roof of the metal shed located on the northeast corner of the structure leaks because of a detached section of ridge. Additionally, the shed doors are missing and the structure is in overall poor condition. Recommend replacing the shed as it appears to be beyond its intended service life.

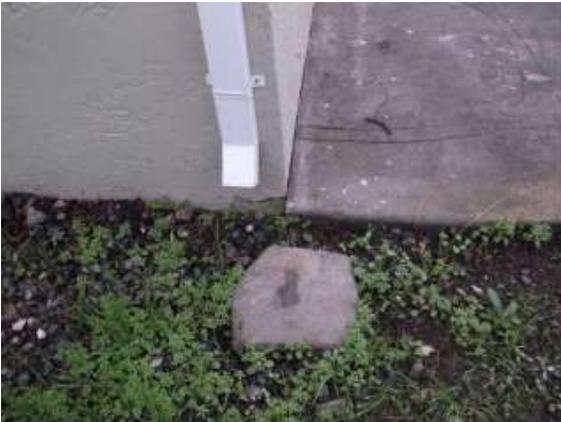
**Photo 14-1**

Splash blocks and/or downspout extensions are missing for most of the structures gutters. This can lead to foundation subsidence and intrusion of wood destroying insects. Recommend installing splash blocks and/or downspout extensions where they are missing. A few example photos are below.

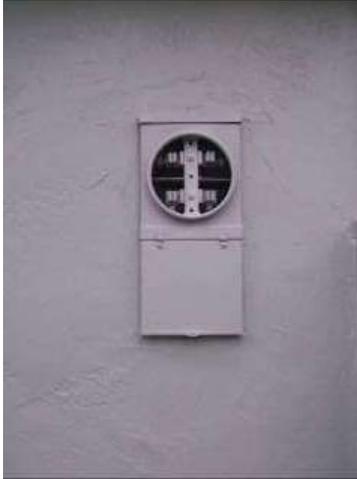
**Photo 15-1**

There is an old and unused main service panel containment box on the west side of the structure which has not been weather-proofed. For example, there is an empty opening for the meter which can allow water to enter the box and further into the interior of the walls. Recommended minimally to close the meter opening, but it would be best to have a qualified contractor remove the old service panel containment box and repair the exterior wall accordingly.

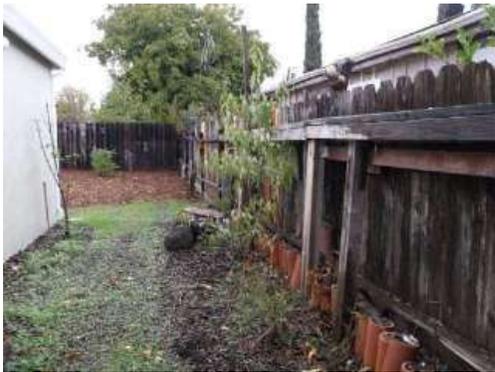
**Photo 16-1**

16) **i** Most of the fencing and gates are in fair condition. Fencing and gates will need to be replaced within 5 years.

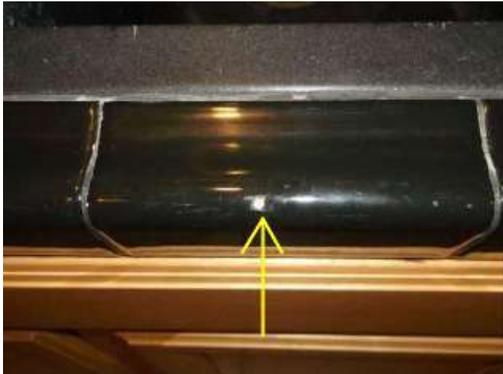
**Photo 18-1**

There are a few small chips in the countertop surfaces. While the chips are small, the clients may wish to have a contractor evaluate and replace chipped tiles if the pattern is currently available.

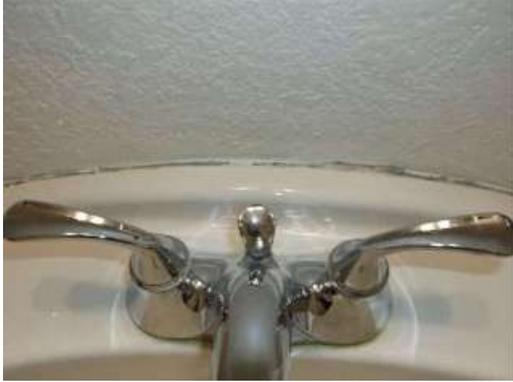
**Photo 19-1**

Caulking is deteriorated along the base of toilets and sinks and along the margins of tubs and backs splash areas in the bathrooms. The existing caulking should be removed and replaced at this time. Example photos are below.

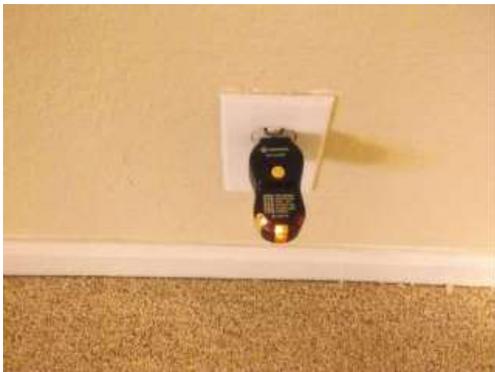
**Photo 21-1**

One three pronged electrical receptacle located on the west wall of the main living area, between the entrance to the kitchen and the hallways has hot/neutral reverse wiring. This is a shock hazard. A qualified electrical contractor should repair as necessary.

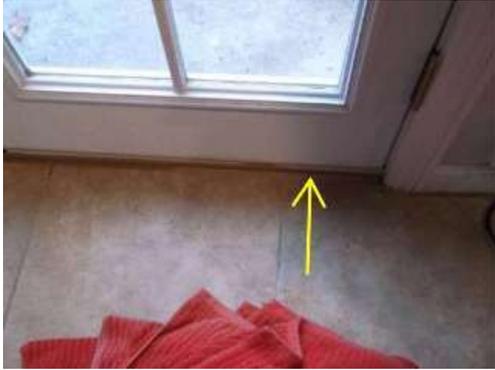
**Photo 23-1**

Water appears to be able to enter under the rear bedroom exterior door. This may be due to improperly installed weather stripping of stripping that is deteriorated. A qualified contractor should evaluate and repair as necessary.

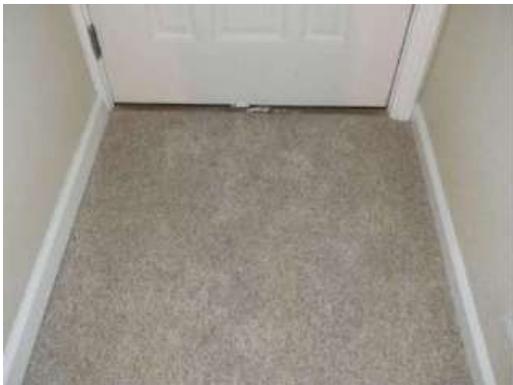
**Photo 25-1**

Carpeting in the east to west running central hallway extends completely to the exterior door of the house. The area surround the entrance way will quickly stain and soil from backyard traffic. Recommend removing three feet of carpeting and replacing it with tile.
